MIRA 36 IN. VANITY

CAVMIR36MB (Midnight Blue)

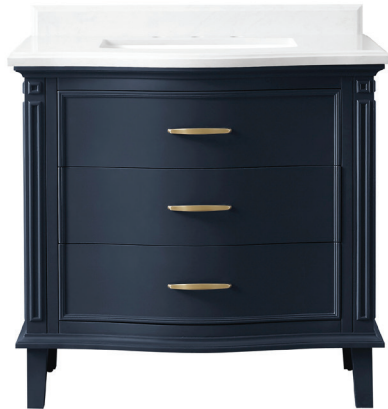
MODEL	CAVMIR36MB
SIZE	21-7/8" L x 36" W x 34-1/2" H
BASIN	15" L x 22" W x 7-1/2" D
VANITY TOP	1" thickness
FAUCET	8 in. Spread
OVERFLOW	None
DRAIN	Rear
WEIGHT	143.3 lbs.
HARDWARE	1 set Brushed Gold 1 set Brushed Nickel
MATERIAL	Wood; Engineered stone
INSTALL	Freestanding

- Midnight blue cabinet with two sets of hardware in brushed gold & brushed nickel
- Made from wood; Engineered stone top & ceramic basin
- Pre-drilled holes for 8 in. faucet; Faucet not included
- Cabinet features two large capacity soft-closing drawers designed to accommodate plumbing; matching 3 in. backsplash
